# Experimental design for determining wear resistance of chisel plough blades

College of Agricultural Engineering Sciences, University of Baghdad, Baghdad, Iraq

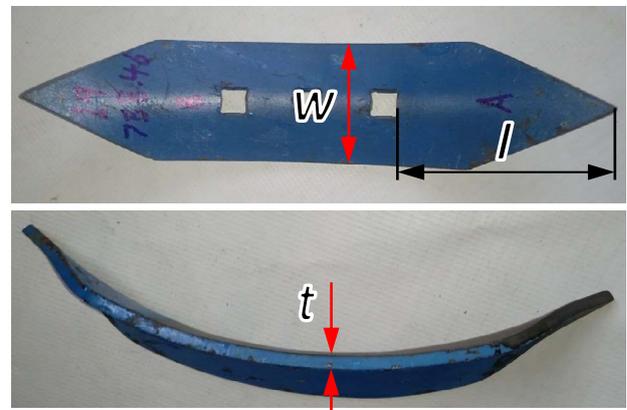
**Figure 1.** Geometry of tested blades ( $w$  – width;  $l$  – length;  $t$  – thickness)

Three chisel plough blades (B1, B2 and B3), available in the local market from various commercial origins, were prepared for testing. Figure 1 illustrates the blade shape, while Tables 1 and 2 present its dimensions, hardness and chemical composition. The hardness and chemical composition were determined at the State Company for Inspection and Engineering Rehabilitation (SIER). For the wear test, gravel with irregular shapes and an average diameter of 5 – 10 mm was obtained from local markets as a dry test medium to accelerate the test. The gravel was washed and dried at room temperature before use.

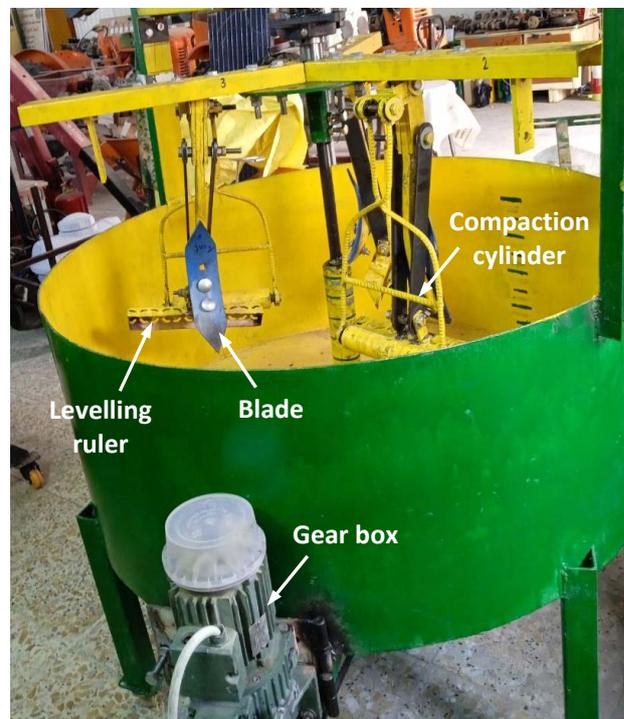
Figure 2. Soil bin

A soil bin was constructed at the University of Baghdad. The soil bin consists of a cylindrical container with a diameter of 1000 mm, a depth of 65 mm and a wall thickness of 4 mm, including a hollow inner cylinder with a 60 mm outer diameter and a 25 mm inner diameter, through which the power transmission shaft passes. The shaft was fixed vertically at both ends with two bars to enable movement while maintaining its vertical position. A shaft was combined at the bottom with a pulley in the power transmission system via a belt. The shaft was combined with three horizontal arms (120° between every two arms) to enable the arms to rotate and vertically move in both directions by using a mechanical assembly designed for this purpose to control the ploughing depth. A vertical bar was fixed on each arm. It supports the shank that carries the blades, the levelling ruler and the compaction cylinder to level and compact the soil after ploughing. A 5 kW three-phase electric motor was used as a power source. It was connected to a control panel with a voltage and current control and measurement unit, and a counter to adjust and record the operating and cumulative working time. The motor was connected to a gearbox to control the rotation speed. The motion from the gearbox to the soil bin is transmitted via a pulley system. The soil bin was painted to protect it from corrosion. Figure 2 shows the soil bin and some of its components.

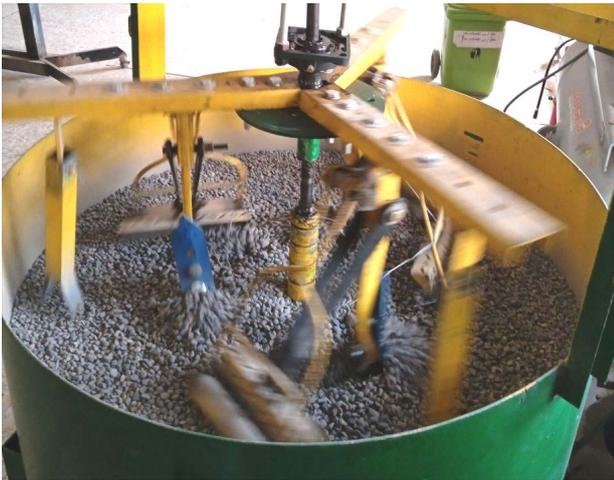
Figure 3. Soil bin filled with gravel

Equipment, College of Agricultural Engineering Sciences, University of Baghdad. An initial run of the soil bin was conducted to verify the working mechanism, the safety of the connection and assembly and the operation and speed control. The soil bin was filled with gravel, as shown in Figure 3, prepared in advance, to a height of 350 mm. Then, the shanks holding the blades with a 30° penetration angle were installed, along with the levelling ruler and compaction cylinder. The bin's operation was organised under controlled operating conditions. Before being used, the blades were thoroughly cleaned with water and alcohol to remove dust. Then, the blades were weighed using a digital electronic balance with an accuracy of 0.01 g, and their length, width and thickness were measured using an electronic vernier calliper with 0.01 mm accuracy.

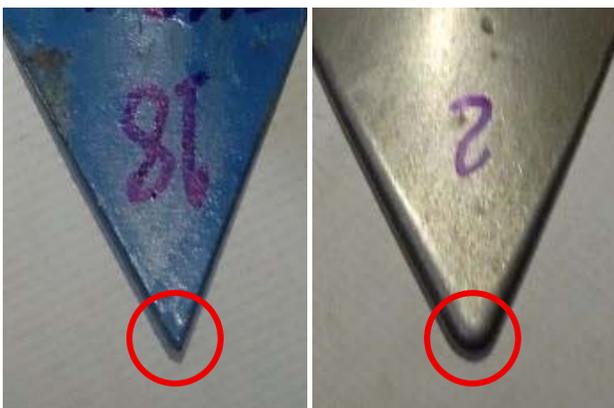
Figure 4. Blade tip before (left) and after wear (right)

Initially, the blades were visually inspected. Wear was noticed on the edges and the blade tip, which had changed from sharp edges to approximately curved ones. Figure 4 shows the change in shape of the blade tip before and after wear. This result agrees with the findings of Tulaganova et al. [24]. The most common method for evaluating the wear of different materials is to measure mass loss and dimensional changes after a predefined sliding distance [25].

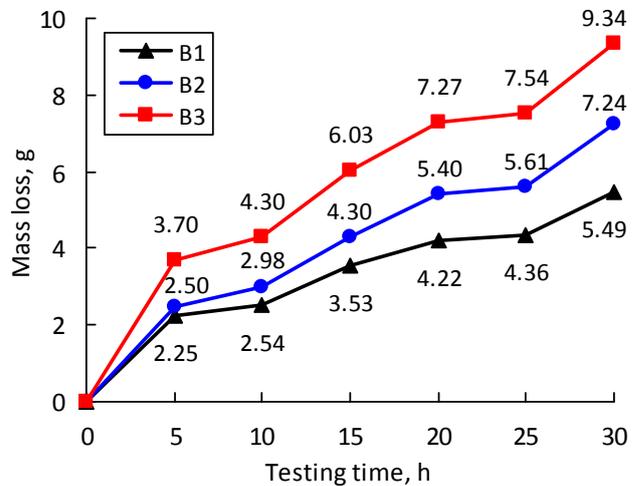
Figure 5. Wear curves for tested blades

Figure 5 displays the cumulative wear of blades for each testing period. All blades show similar wear patterns. Furthermore, it was found that wear increased as the test progressed. However, the first testing period (5 hours) showed the highest wear rate for all blades. After that, the wear rate significantly decreased in the second period.

Nevertheless, in subsequent periods, the mass loss was not constant, but rather increased and decreased until the end of the test. This behaviour may be explained by gravel sliding on the blade, which can cause pressure on the surface. Hence, this process causes surface residual stress, somewhat increasing the hardness. This increase, although small, can lead to an improvement in wear resistance. Subsequently, the wear rate continues to fluctuate throughout the testing. In the first period, blade B3 exhibited the highest mass loss, reaching 3.70 g. At the same time, blade B1 showed the lowest value of 2.25 g during the same period. At the end of the test, blade B3 exhibited the maximum cumulative mass loss after 30 hours (total time), reaching 9.34 g, whereas B1 had the lowest cumulative wear of 5.49 g during the same period.

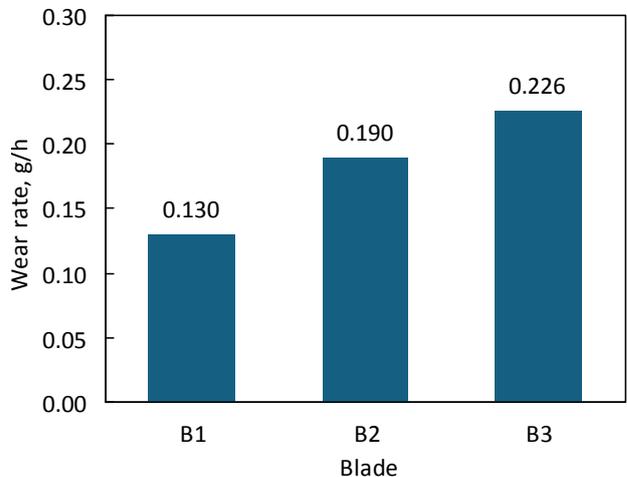
Figure 6. Wear rate of the tested blades for the steady-state period

Figure 6 shows the wear rate of each blade in g/h for the steady-state period (last 25 hours). Blade B1 had the lowest wear rate of 0.130 g/h, approximately 57 % of the wear rate of blade B3, which had the highest wear rate of 0.226 g/h.

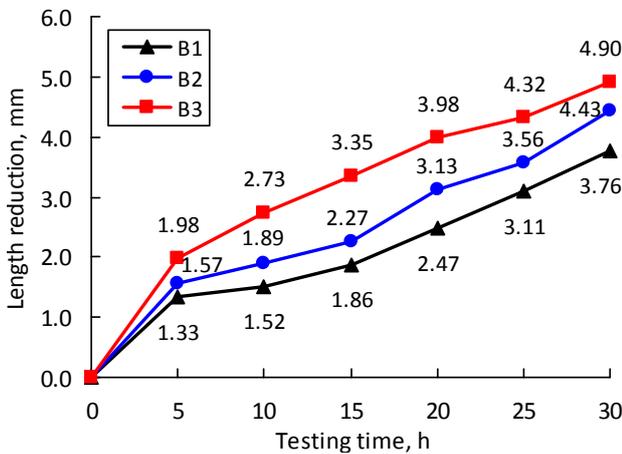
Figure 7. Length reduction of the tested blades

According to the results, the decrease in dimensions (length and width) followed a similar pattern to the mass loss of each blade. Figures 7 and 8 show that the length and width of the tested blades have decreased. Furthermore, it was noticed that the dimensions decreased as the test continued. This result agrees with the findings of More et al. [22]. Also, it was noted that the lowest cumulative reduction in dimensions (length and width) was in blade B1, as it reached 3.76 mm (3.6 %) and 0.85 mm (1.2 %), respectively, while the greatest reduction in dimensions was in blade B3, as it reached 4.9 mm (4.7 %) and 1.75 mm (2.5 %), respectively. Thus, the reduction of blade B1 in length and width is 76 % and 48 %, respectively, compared to blade B3. This result agrees with the findings of Chotěborský et al. [26].

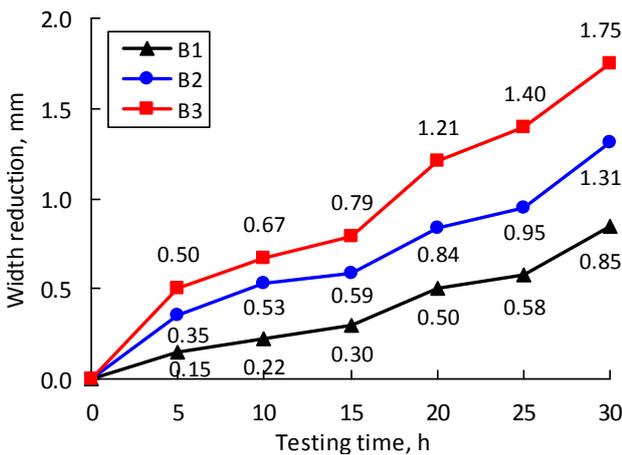
Figure 8. Width reduction of the tested blades

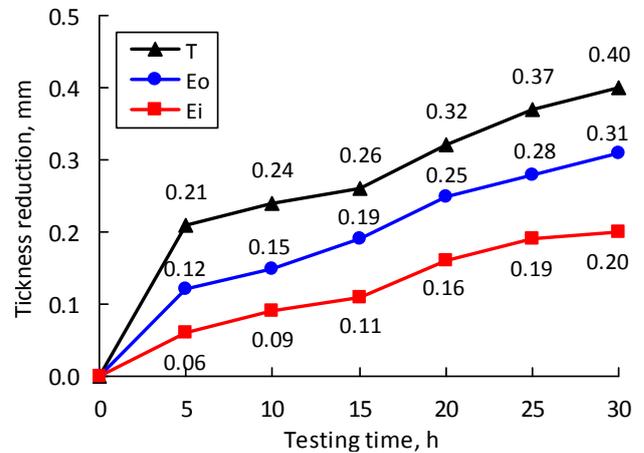
Figure 9. Thickness reduction of blade B1 (T – blade tip; Eo – outer edge; Ei – inner edge)

The thickness reduction of the blades was shown in Figures 9, 10 and 11. It was also noticed that the thickness reduction increases over time, as does the length and width. Furthermore, it was noticed that the thickness reduction of each blade differed by its location, with the blade tip (T) exhibiting the

maximum thickness reduction, followed by the outer edge (Eo), which was farthest from the centre of rotation and then the inner (closest) edge (Ei), which had the lowest thickness reduction. The reasons for these differences depend on the location. The blade tip shows the greatest thickness reduction because its small area allows pressure

and friction to act on it from all sides, resulting in severe, intensive wear. At the same time, the difference in thickness reduction between the blade edges comes from the working mechanism of the circular soil bin. The plough blade's circular movement creates a variation in the radius of rotation between the two edges of the blade equal to its width. As the movement continues, this variation causes a slight increase in the sliding distance of the blade's outer edge. Continued work results in a noticeable increase in wear.

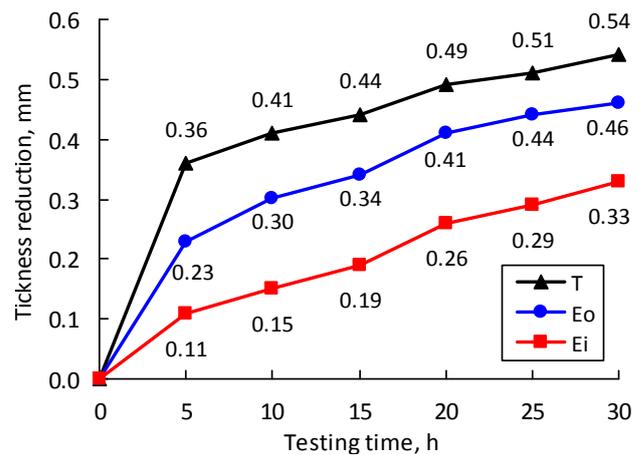
Figure 10. Thickness reduction of blade B2 (T – blade tip; Eo – outer edge; Ei – inner edge)

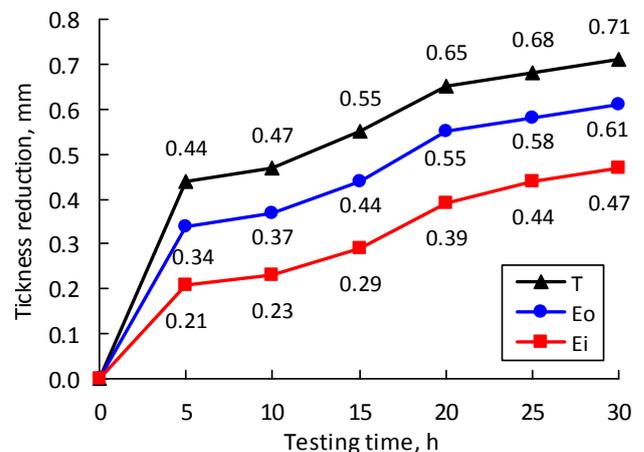
Figure 11. Thickness reduction of blade B3 (T – blade tip; Eo – outer edge; Ei – inner edge)

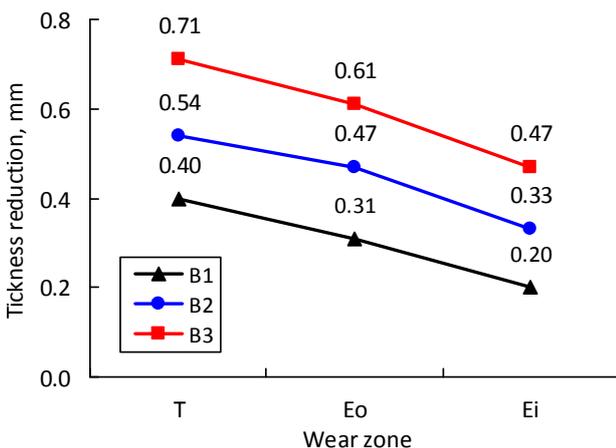
**Figure 12.** Thickness reduction at all zones of the tested blades

Figure 12 shows the total thickness reduction for all blades at the same zones. It differed from one blade to another. It also shows that blade B3 had the greatest thickness reduction across all zones, i.e. 0.71, 0.61 and 0.47 mm for zones T, Eo and Ei, respectively, while blade B1 had the lowest reduction, reaching 0.40, 0.31, and 0.20 mm for the same zones. In comparison, blade B2 exhibited wear values that were approximately average between those of blades B1 and B3 in all wear evaluations.
